## Repair of warped dial scale - Sony CRF-5090.

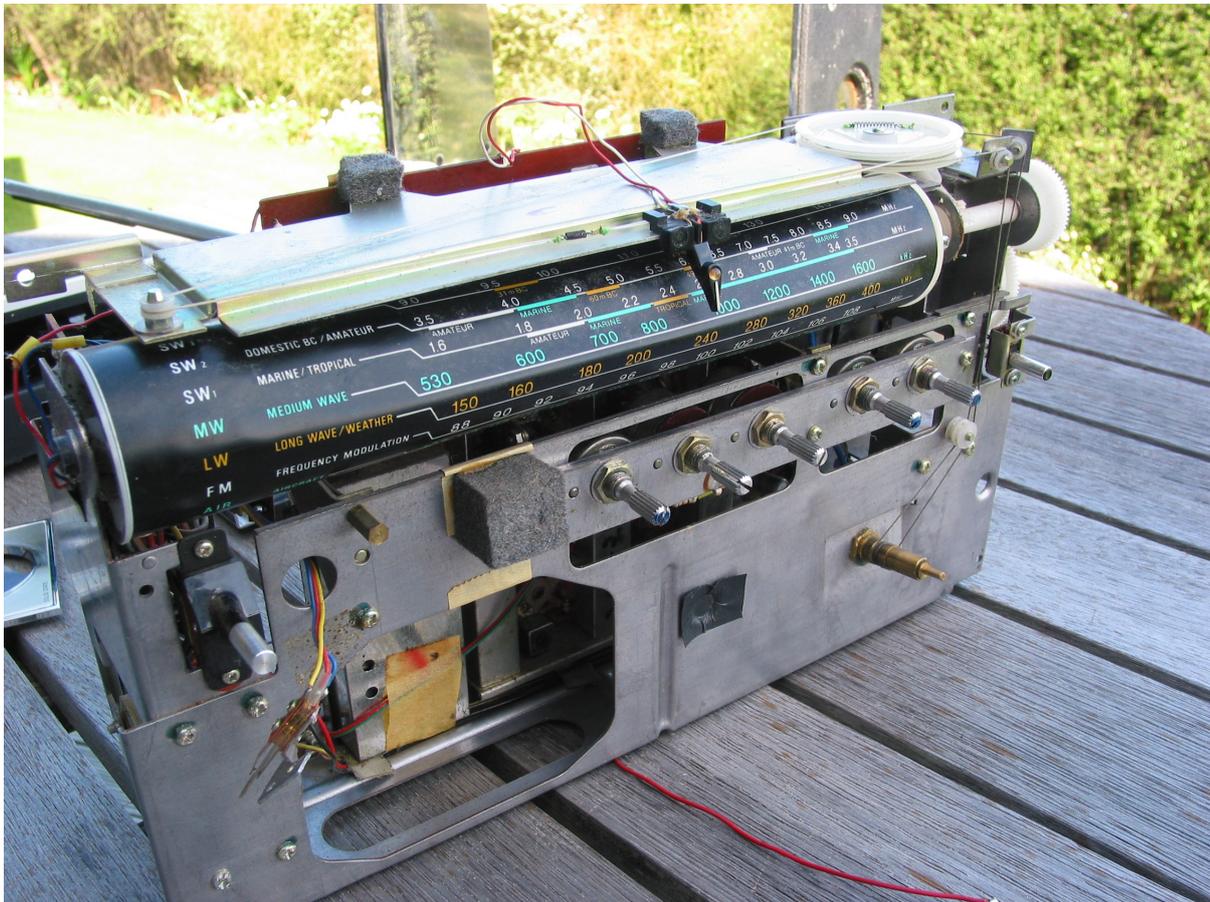
The scale appeared to be “flattened” only on one side. The previous owner said that he used the receiver only on the aircraft band and that it was always used with mains power. With the aircraft band selected, the “flat” section was uppermost. When run on mains power, the scale lamps are always illuminated, so perhaps the scale is softened by the lamp heat.

Figure 1 - the scale before removal.

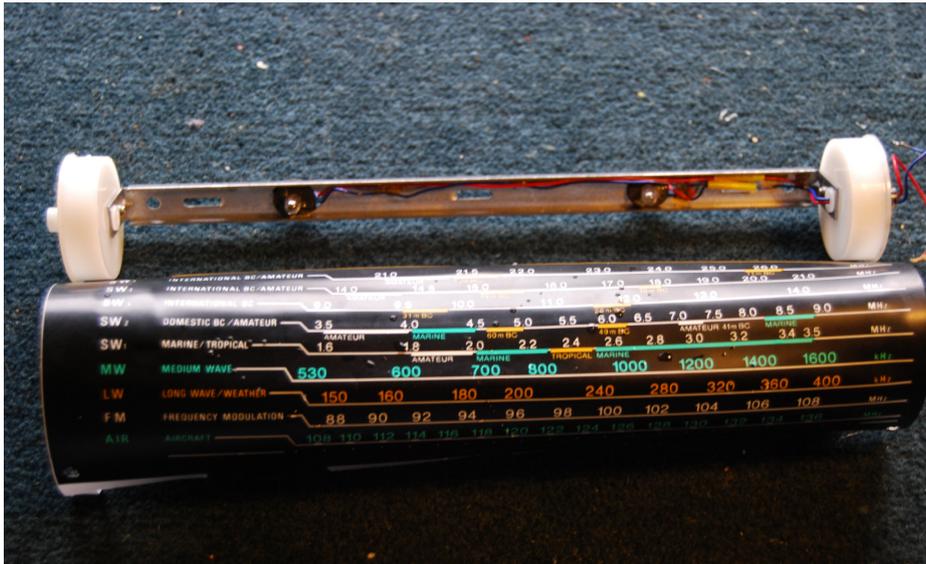
Fig 2 - Scale removed.

The scale can be removed quite easily after unsoldering the dial lamp leads from their tagstrip. Loosening the screws on the right hand end shaft coupler allows the coupler to be slid down the shaft. There is now sufficient space to lift the shaft out with the dial. The left hand end just sits in a hole in the mounting plate.

The scale is attached to the two drum ends by two self tapping screws, a melted plastic “rivet” and some double-sided tape. A small hole was drilled through the plastic “rivet” with a drill held in a pin chuck - the excess plastic was chipped away with a scalpel blade. The two self-tapping screws were removed. The double-sided tape had gone quite brittle and was carefully sliced through, again with a scalpel blade. With the scale removed, the remaining dried out glue was softened and washed away from the drum ends and the back of the scale. It was found that the scale was not affected by water, but solvents were avoided.

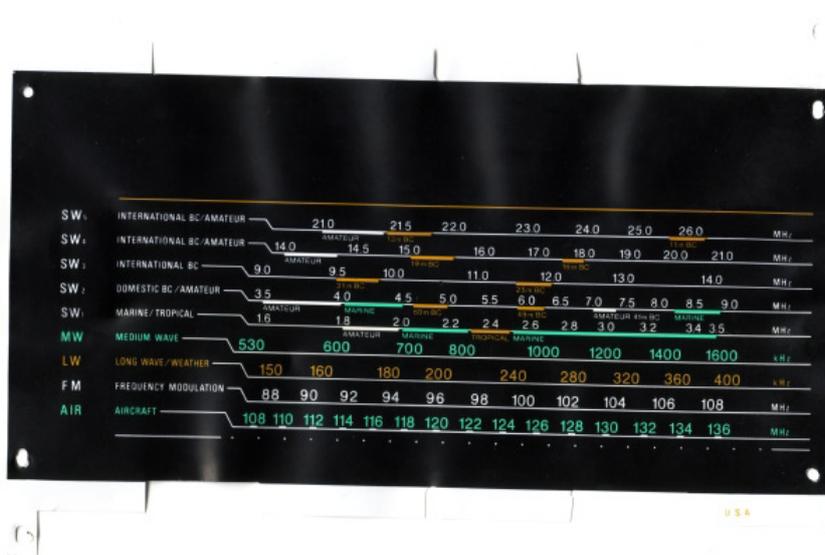
The scale was gently flattened and then scanned at 600dpi in case of accidents!

Fig 3. Scanned scale:

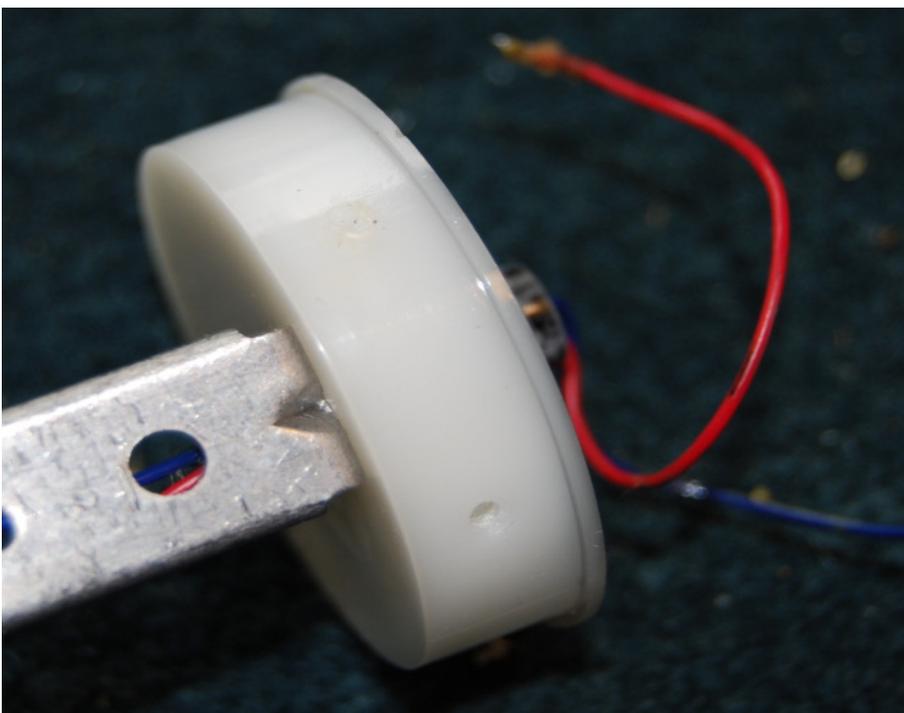
Fig 4. Scale drum end.

The edges of the scale were cut with a craft knife and straight edge, and made the holes square with a scalpel. (I would have liked to use a leather punch but don't own one and a paper hole punch is too big.) The holes in the drum where the plastic rivets were drilled out were tapped to fit small screws.

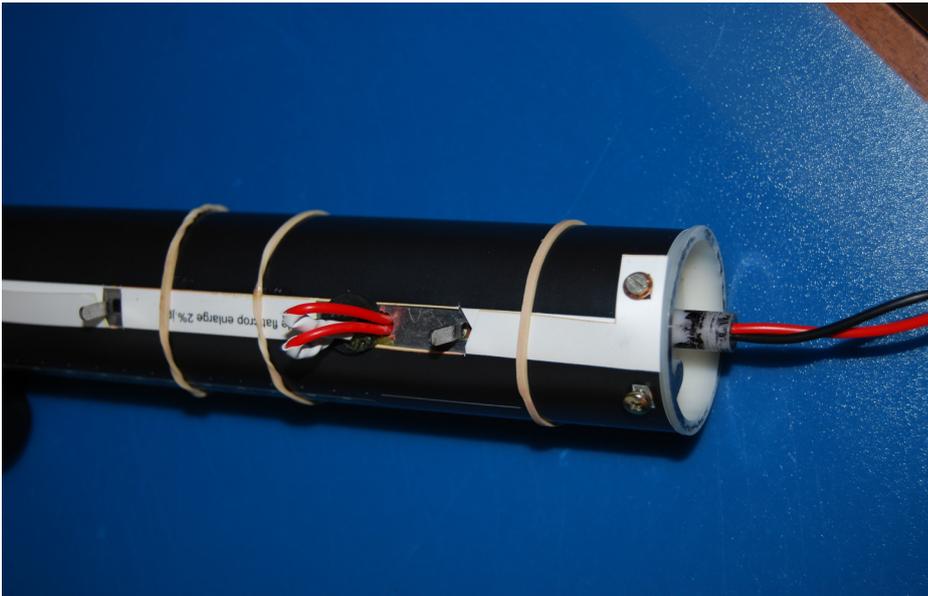
Fig 5. Scale glued.

The inner end of the scale was fitted to the drums and attached loosely with (now) two screws and then fed the scale around and held in place with elastic bands. The other two screws were then fitted loosely too. The grommets holding the LED's were fitted over the ends of the scale and everything adjusted for best fit. The centre flaps were then glued down to each other with contact adhesive and allowed to dry. Using adhesive applied with a screwdriver blade, glued down the rest of the flaps to each other. Pressure was applied with more elastic bands. The small tabs were bent over.

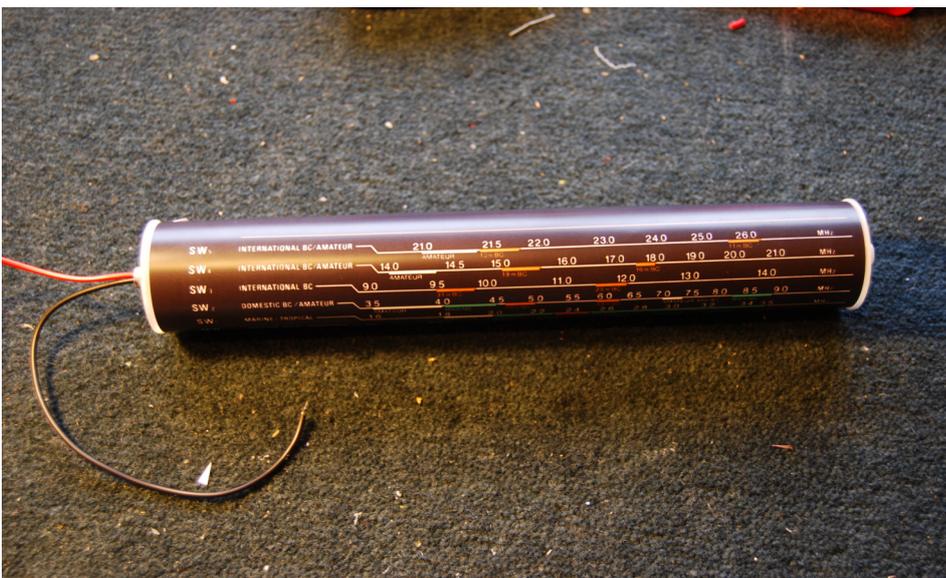
Fig 6. Finished scale.

The ends flaps were then adjusted for best fit and the four screws gently tightened. As the new scale is slightly thicker than the original, it was decided that gluing of the scale to the drum ends was unnecessary.

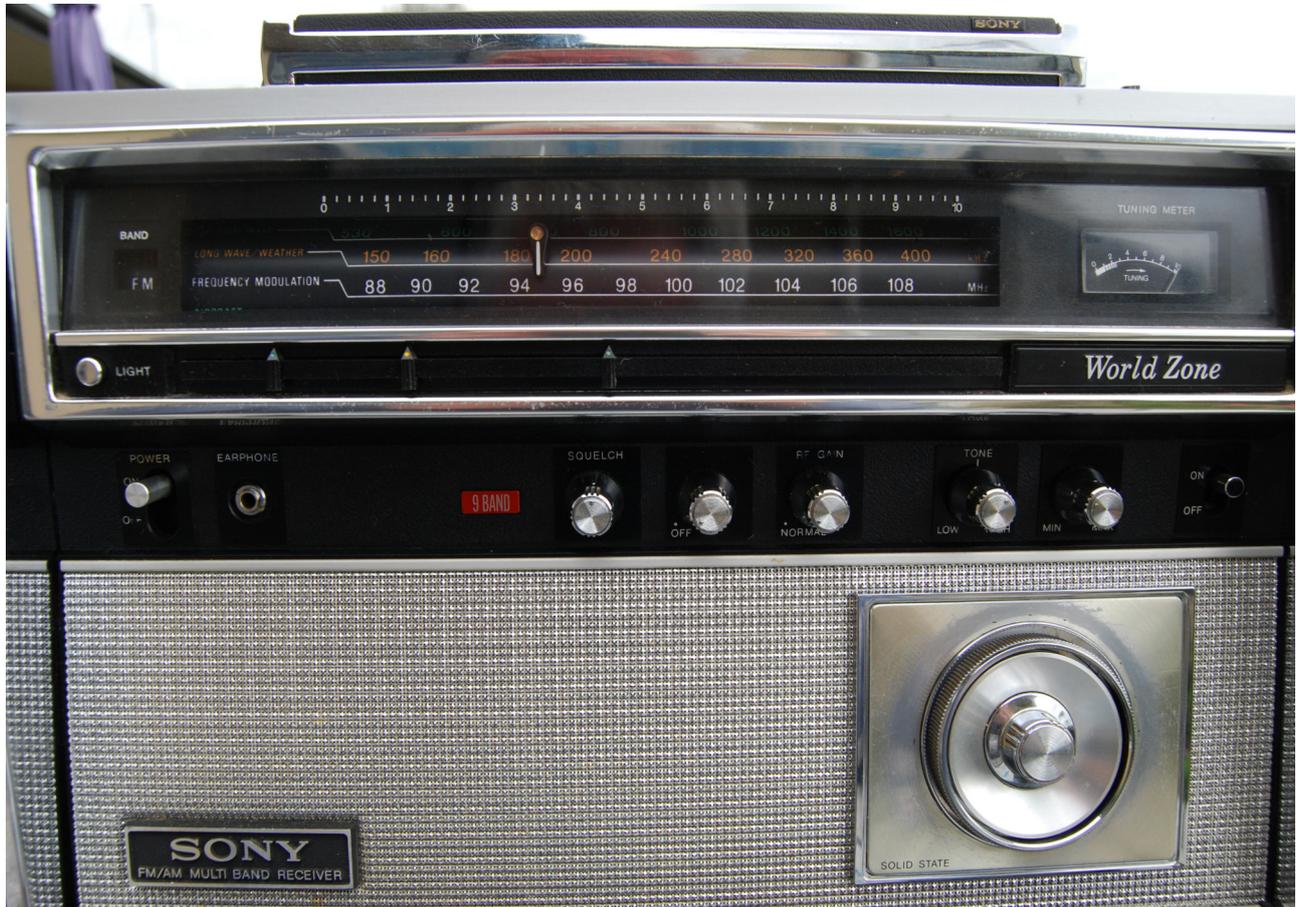
Fig 7 Complete.

The scale was then refitted into the radio and the LED's connected. A trial run of lamp brilliance was satisfactory with the scale lightly but evenly illuminated on mains power and with adequate brilliance when the "Light" button is pushed. A check of the scale calibration showed that no adjustment was required. The chassis was then fitted back into the case and now looks really good.
